Report No. CG-WEP-2-79

FATE OF OIL SPILLED FROM THE  
SUPERTANKER METULA

JANUARY 1979

FINAL REPORT

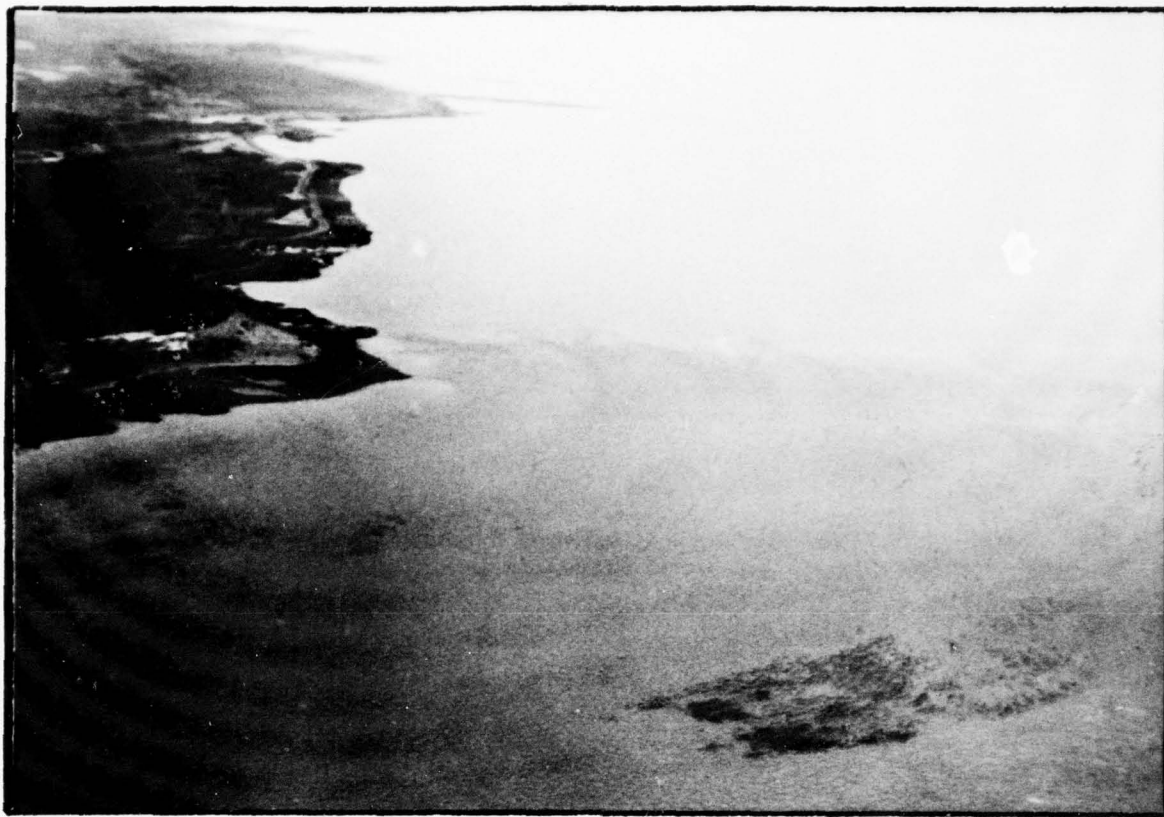
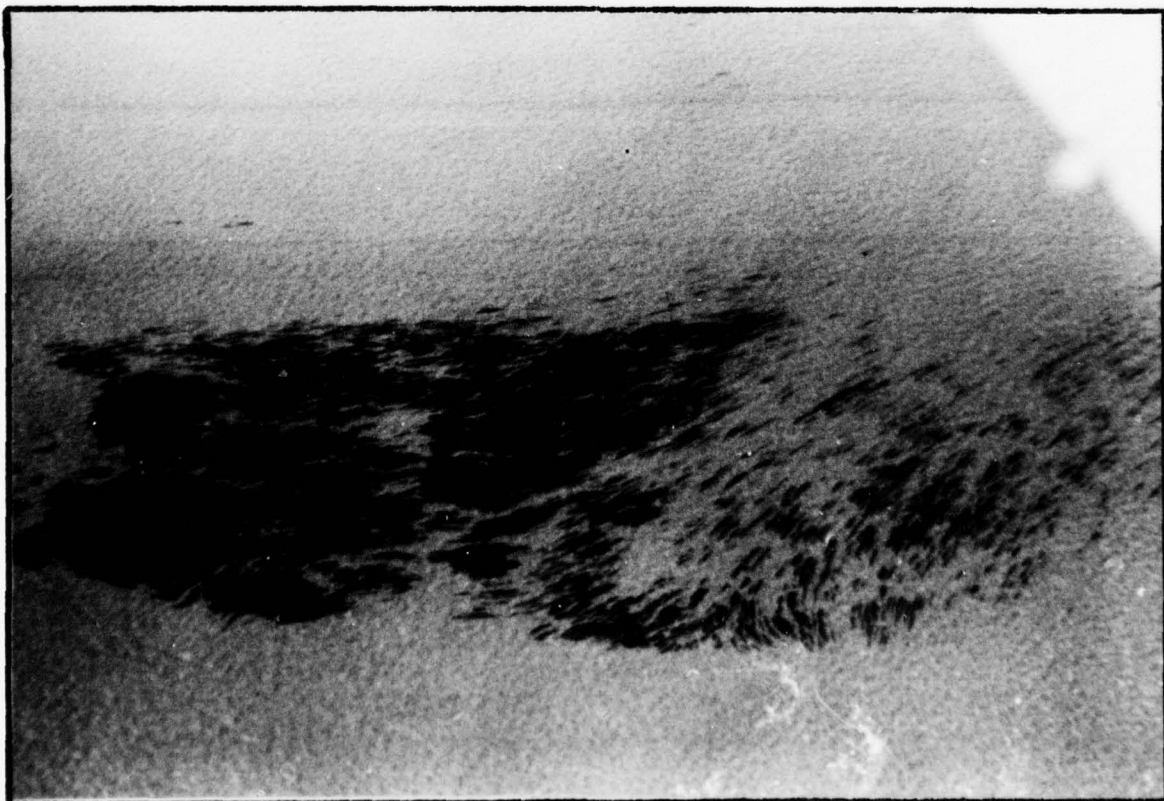
FIGURE 7

- A - Grounded tanker METULA on Satellite Patch with south shore of South American Continent in the background.
- B - Grounded tanker METULA with lighting tanker HARVELLA alongside. Oil is shown spreading over the water surface.

On August 29, the small Argentinean tanker HARVELLA of 19,000 deadweight tons was brought alongside and the initial pumping of oil from the METULA was carried out as part of the attempt to minimize pollution and to remove sufficient oil to float the ship. In Figure 7 Part B, the tanker HARVELLA is shown alongside the METULA unloading the cargo.

evident in both Bay Felipe and Bay East of the Narrows. The surface slicks, however, were much more evident on the flight on September 5 than they were on the initial flight over on August 28. Views of the surface slicks are evident in Figure 7 Parts A and B.

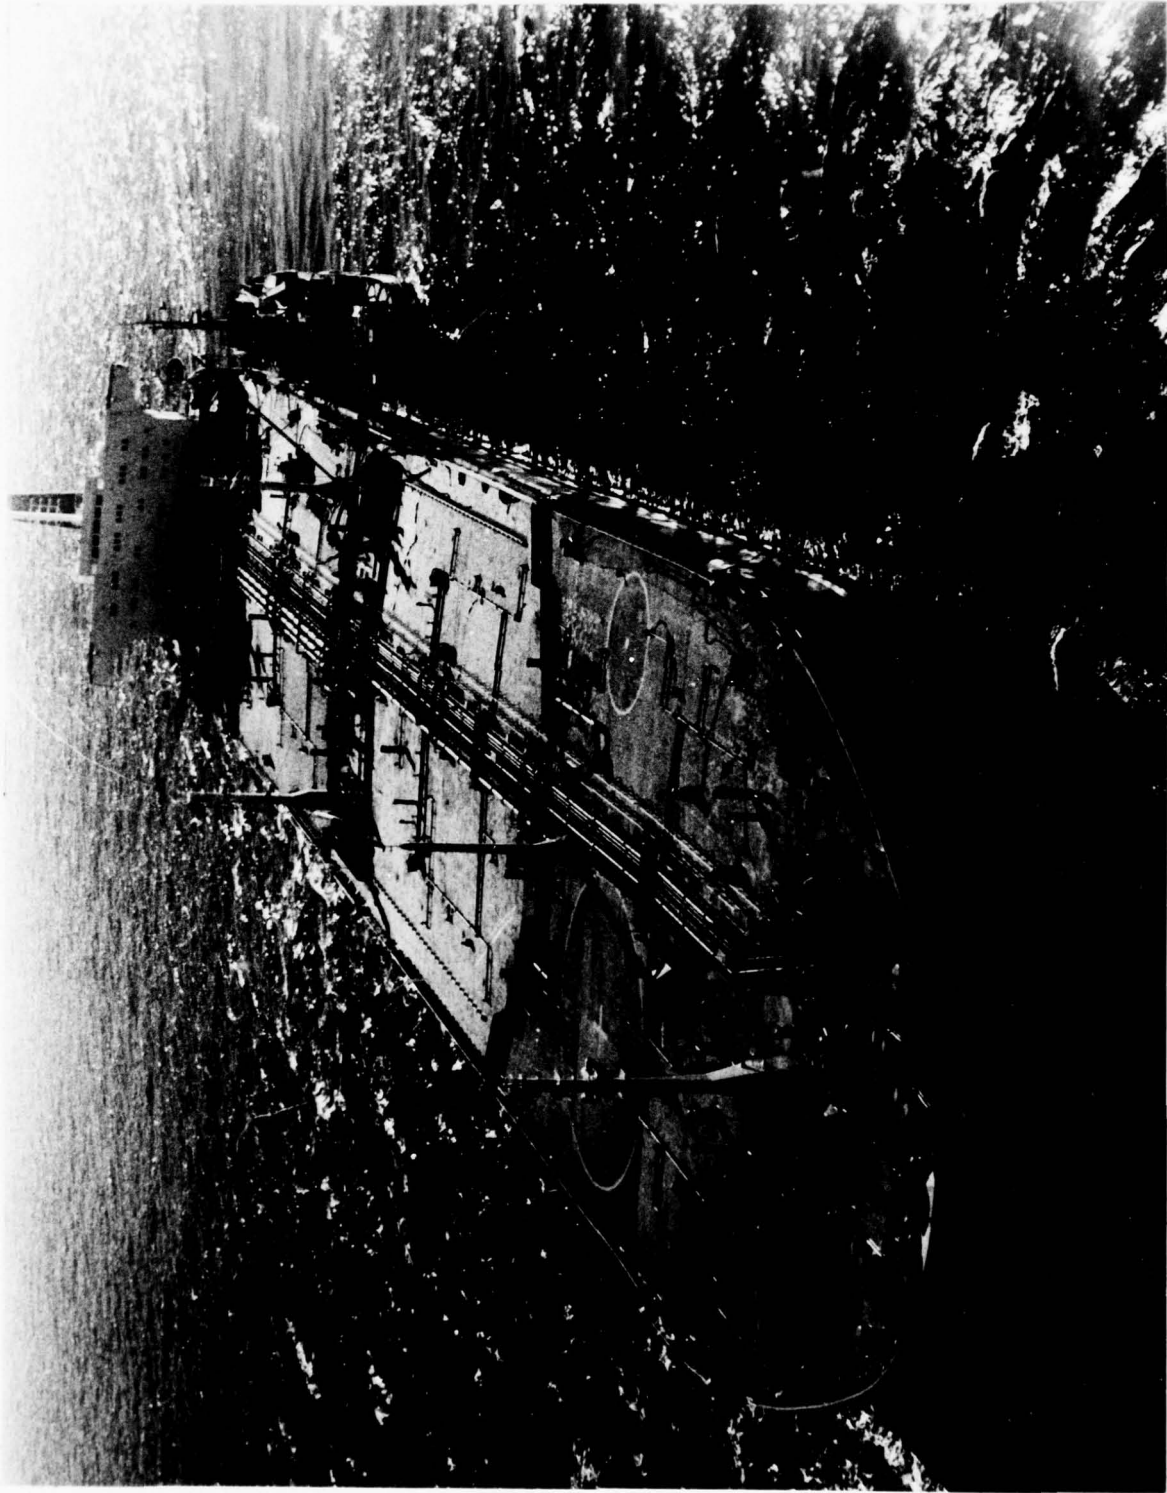
FIGURE 8

CLOSEUP OF GROUNDED TANKER *METULA* WITH TUG ALONGSIDE

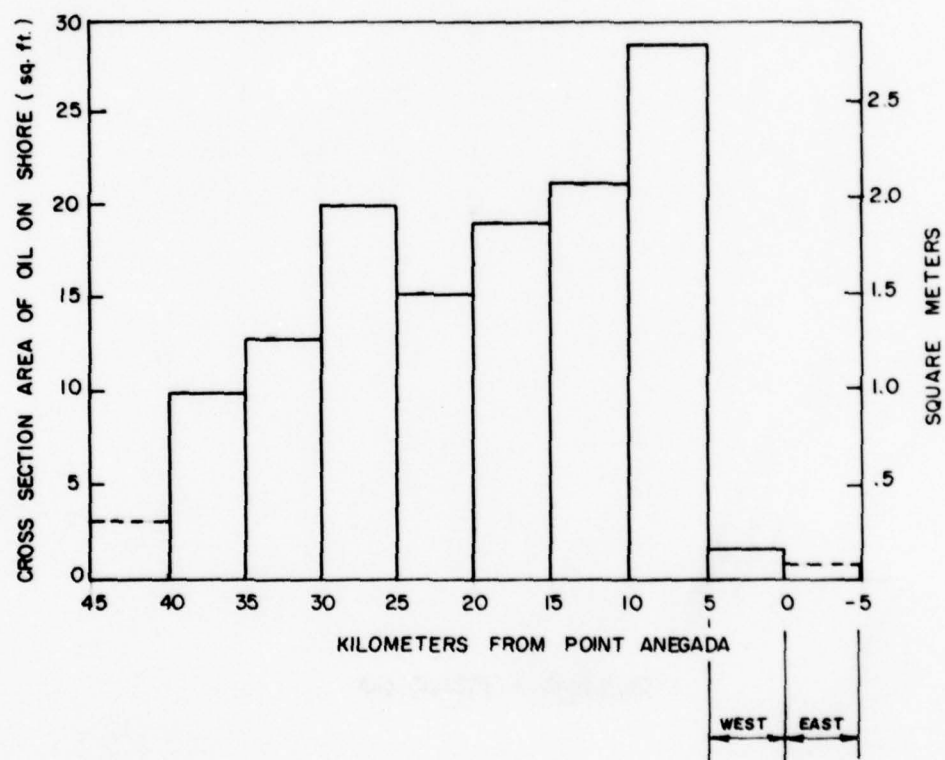
**FIGURE 10**  
**ESTIMATE OF OIL ON SHORE**  
Aug. 31, 1974 - Sept. 1, 1974

The location in different sectors is shown in Figure 10. Based on these crude estimates some 60,000 cubic meters of mousse was on the coastline at that time. Laboratory analysis of two collected samples led to the belief that the average water concentration of the mousse was 30 percent. This figure is lower than experienced on some later spills which show water

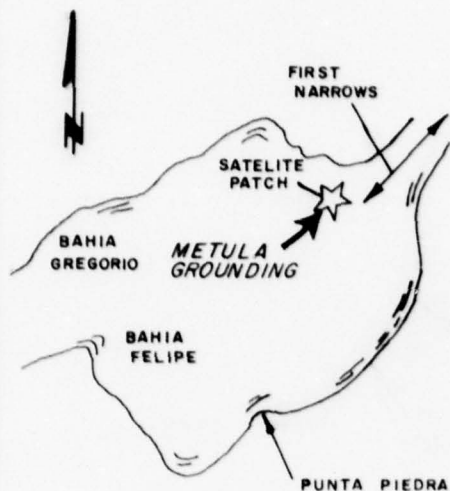
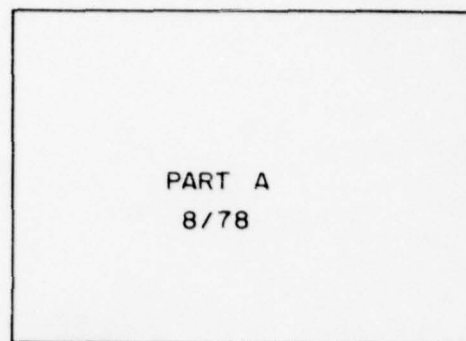
FIGURE 12

Figure 12 Parts A and D show the general area and Parts C and E show closeup of the marine community on, around and under the cobbles. The only oil found in this area has been a tar residue on occasional rocks found at the upper intertidal zone. A handfull of rocks gathered over a half-hour period is shown in Figure 12 Part B.

- A - Typical view of uncontaminated beach showing steep sand beach, stranded detritus and near top of beach and cobble area in lower Intertidal Zone.
- B - Tarred rocks found on Gregorio Beach.
- C - Crustacea living under cobbles in lower Intertidal Zone.
- D - Lower Intertidal community with cobbles, algae and marine life.
- E - Close-up of limpets and mussels in lower Intertidal Zone.

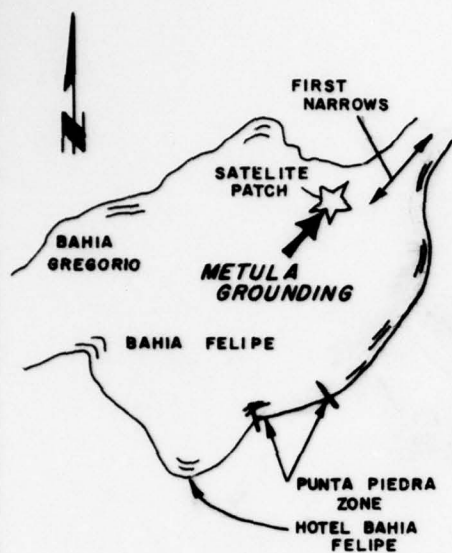
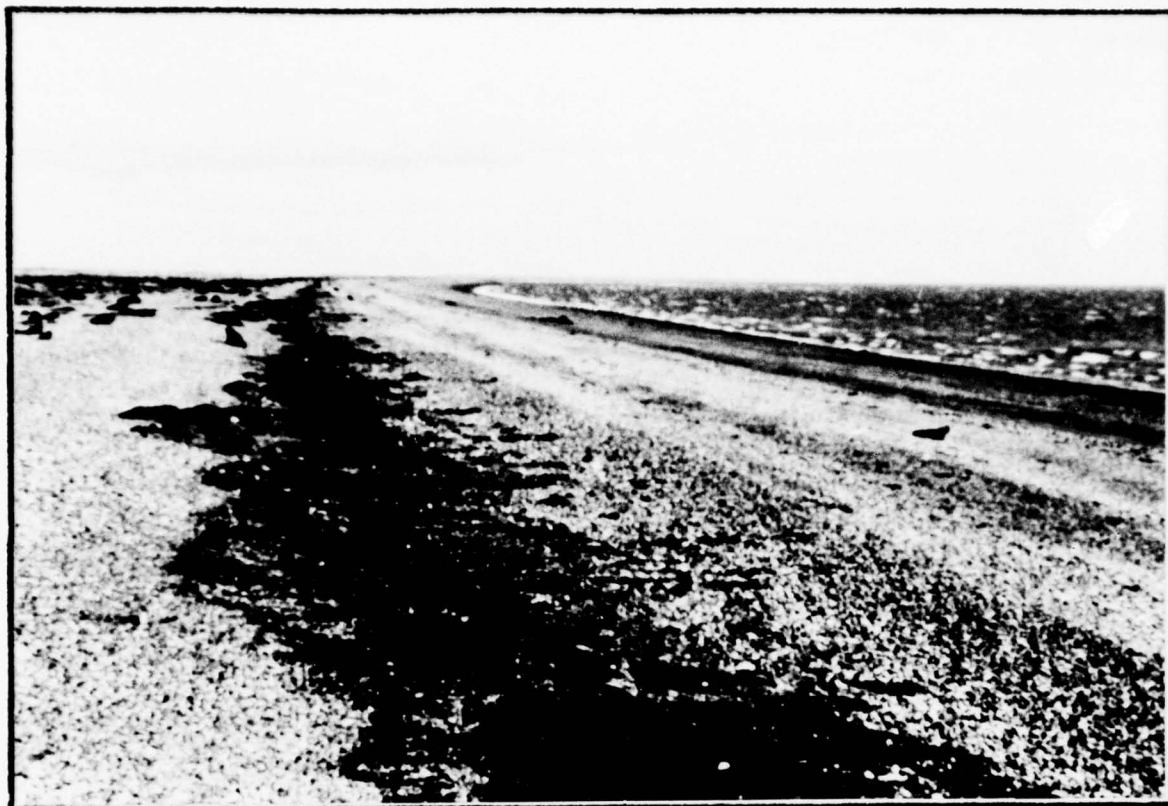
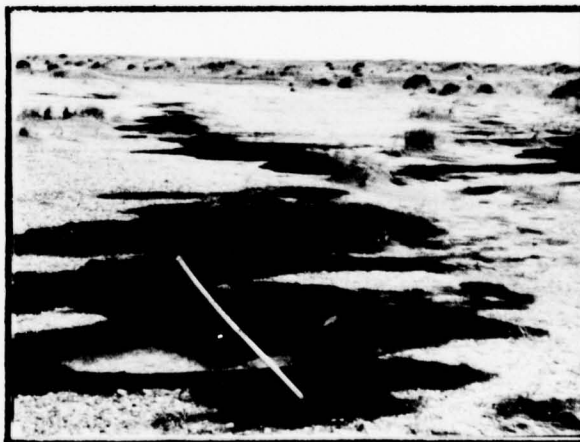
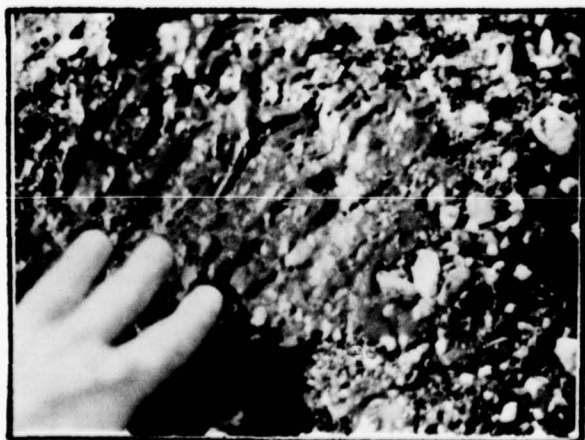
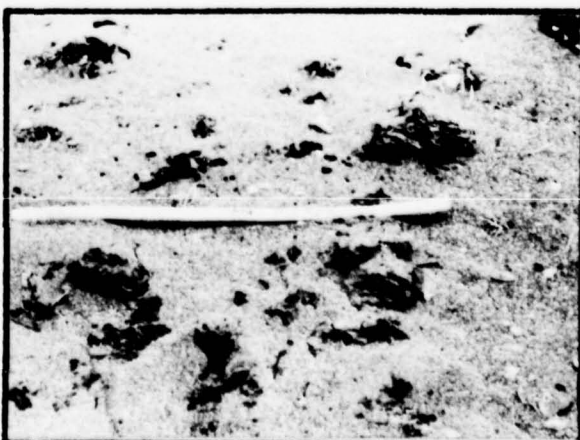
FIGURE 13

At the Punta Piedra site some 8 km to the east, the band was slightly wider at the top of the beach but similar in thickness and consistency. The summer sun of the area acting on the thin dark mousse layer caused the mousse to become warm and thin and to penetrate into the surface sand. This penetration permitted the evaporation of the light ends and water and left a layer of crusty black oiled sand which has been gradually eroding away under the influence of the wind and surf.

Figure 13 shows a series of photographs for this area. Part A and Part B show the deposit at the beach top in January of 1975 and Part C shows the still soft mousse appearance of the deposit at that time. Parts D and E show the same zone two years later. In one case a stretch is shown which has been little changed in coverage whereas in the other only small patches of the oiled crust remain.

- A - Deposition of oil at top of beach near Hotel Bahia Felipe.
- B - Closeup of deposit at top of beach.
- C - Closeup of disturbed surface showing soft mousse which has not yet penetrated into the sand.
- D - Similar area near Punta Piedra two years later.
- E - Area two years later where crust has been eroding away.

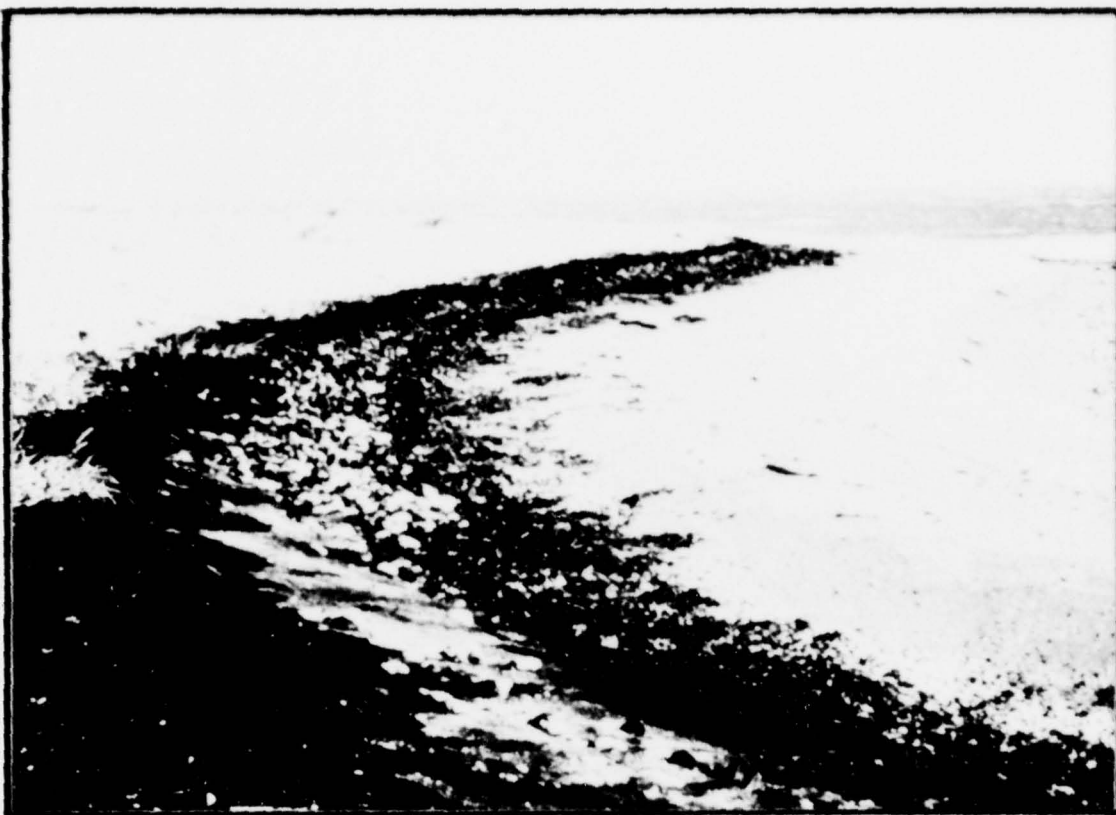
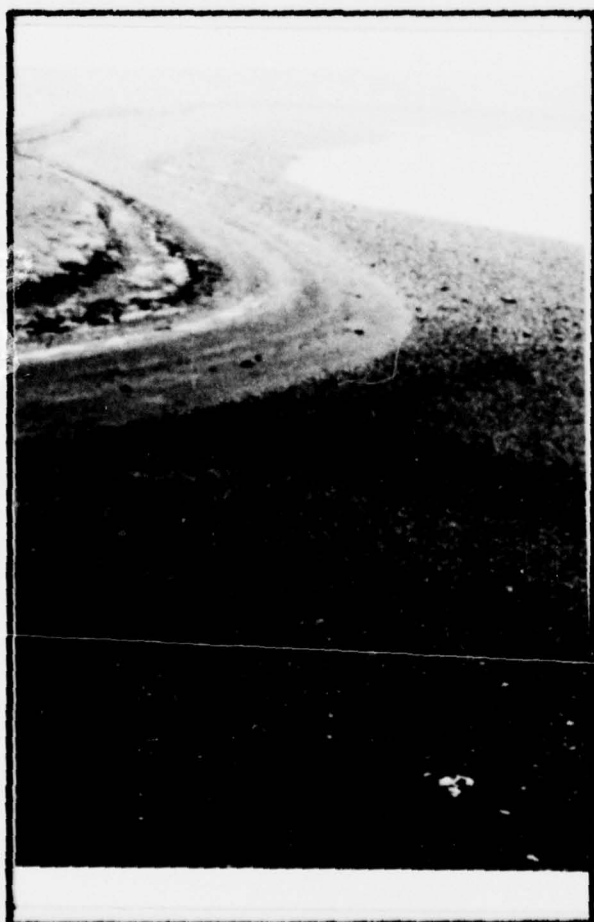
FIGURE 14

On Figure 14 Part A this latter stretch of beach is shown as it appeared in January of 1975. Part B shows an aerial shot of Punta Remo taken in January of 1975. The oiled stretch at the top of the beach and the large cobbled intertidal zone are evident. Part D shows a closeup of the stranded mousse in 1975. Mousse that has been warmed by the sun may be observed oozing down the beach face. Part C of Figure 14 shows the beach top area in 1978. The zone of coverage remains the same. The texture of the oil has changed in that most of the oiled layer now consists of oiled sand rather than mousse. There are, however, some areas where

- A - Oil stranded at the top of the beach in the Punta Remo area.
- B - Aerial photograph showing oiled beach top, sloping beach and wide cobbled zone exposed at low spring tides.
- C - Close-up of oiled beach top near Punta Remo.
- D - Oil leaching from beach top deposits under the heating effect of the summer sun.

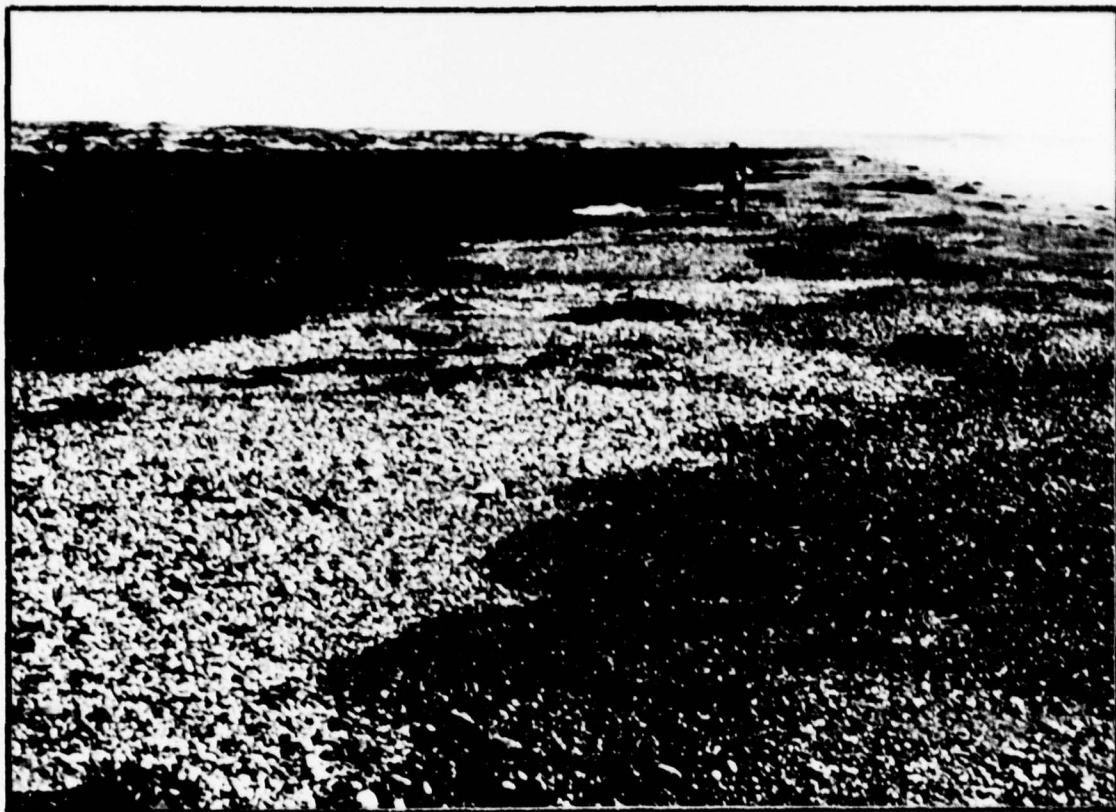
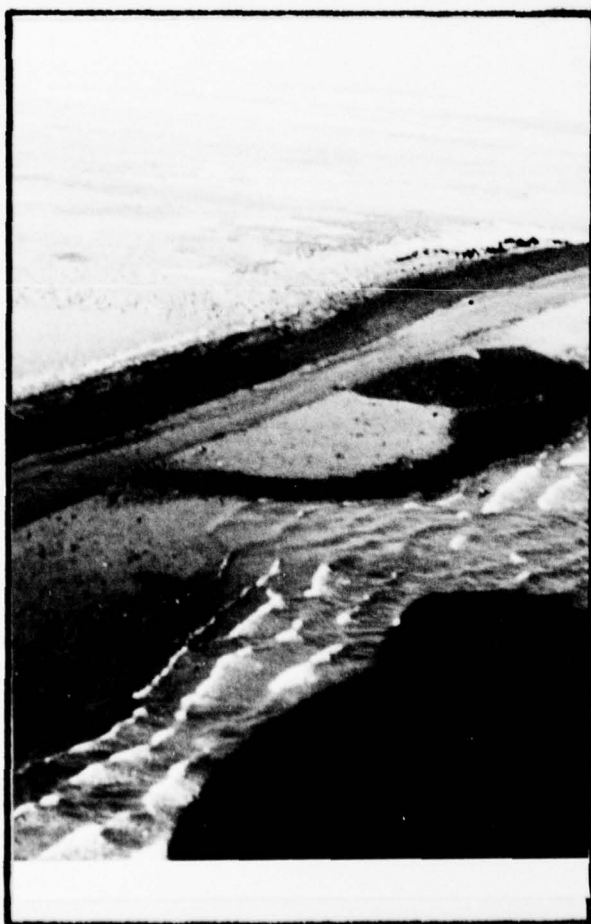
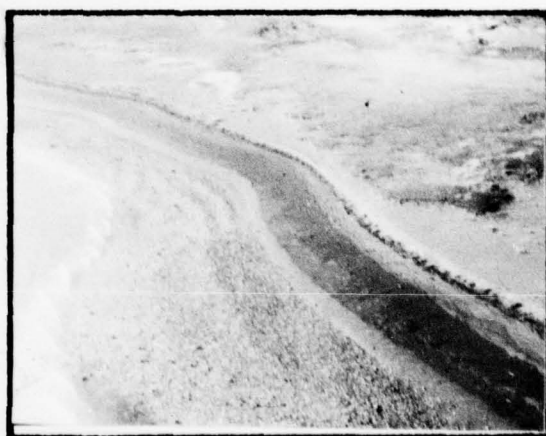
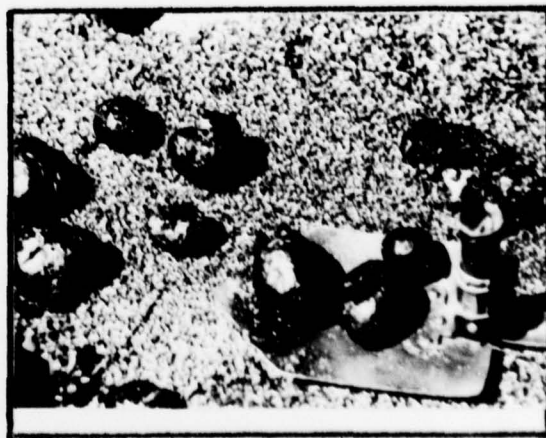
FIGURE 15

The Southeast Arc area of the beach served as the center of a large natural boom to collect the oil driven by the wind across Bahia Felipe. At the time of the spill in August of 1974 the oiled zone on this beach was over 30 meters (approximately 100 ft) wide. Mousse pooled against the shore at that time is shown in Figure 15 Part B.

The wave on the beach in this zone had brown oil stained edges from resuspended oil which would leave random wavy lines in the lower zones of the beach as the tide would come in and go out. Figure 15 Part A shows a typical view of this stretch of beach in January of 1975. Figure 15 Part D shows a group of tarballs found at the base of the beach slope in January 1976.

- A - View of oiled beach top in maximum impact area on Bahia Felipe, exposed oil is to the left of the picture and covered oil under the sand on the right.
- B - Aerial photo of southeast arc area of Bahia Felipe during the time of the spill.
- C - Aerial photo of similar area five months after the start of the spill.
- D - Tar balls found at the base of the beach slope.

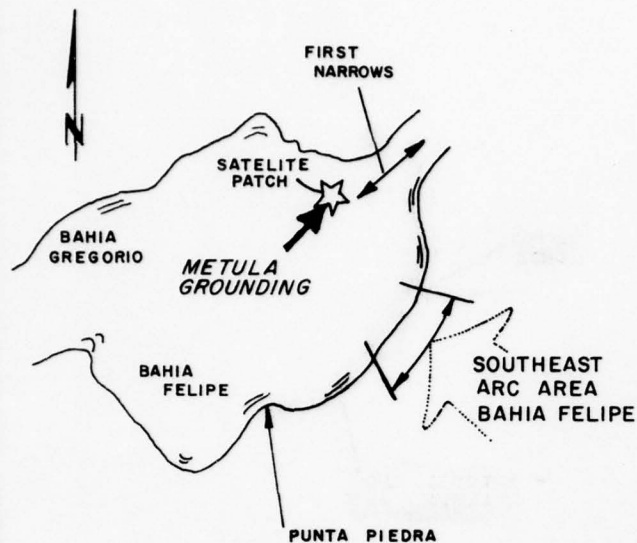
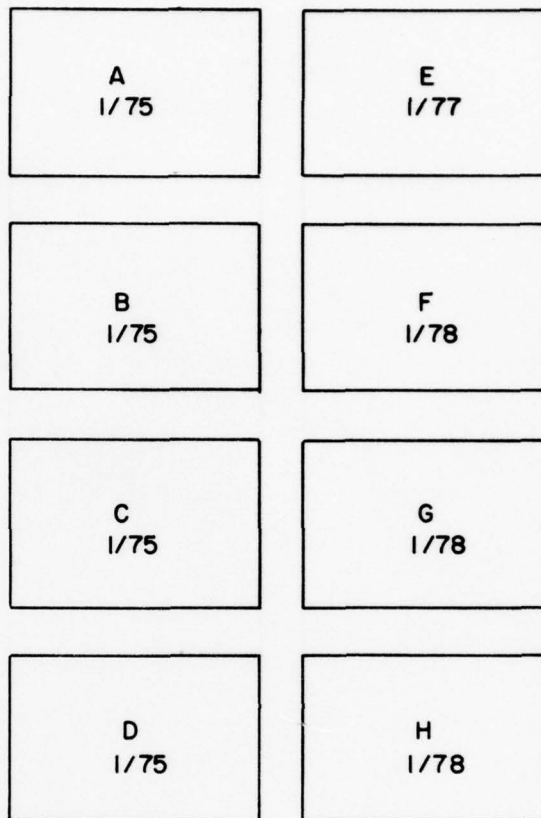
FIGURE 16

Figure 16 Parts A through D show other views taken in this area in January 1975. These may be contrasted with those in Figure 16 Parts E through H which show the same area in January 1977 and 1978.

- A - Oiled beach top southeast arc.
- B - Weathered oil outcropping in beach.
- C - Oil outcropping in beach.
- D - Close-up of oil outcropping in January 1975.
- E - View of oil deposits at top of beach.
- F - View of oiled outcrop 3 1/2 years after the spill.
- G - Close-up of oiled outcrop after 3 1/2 years.
- H - Hole through oiled layer at top of the beach.

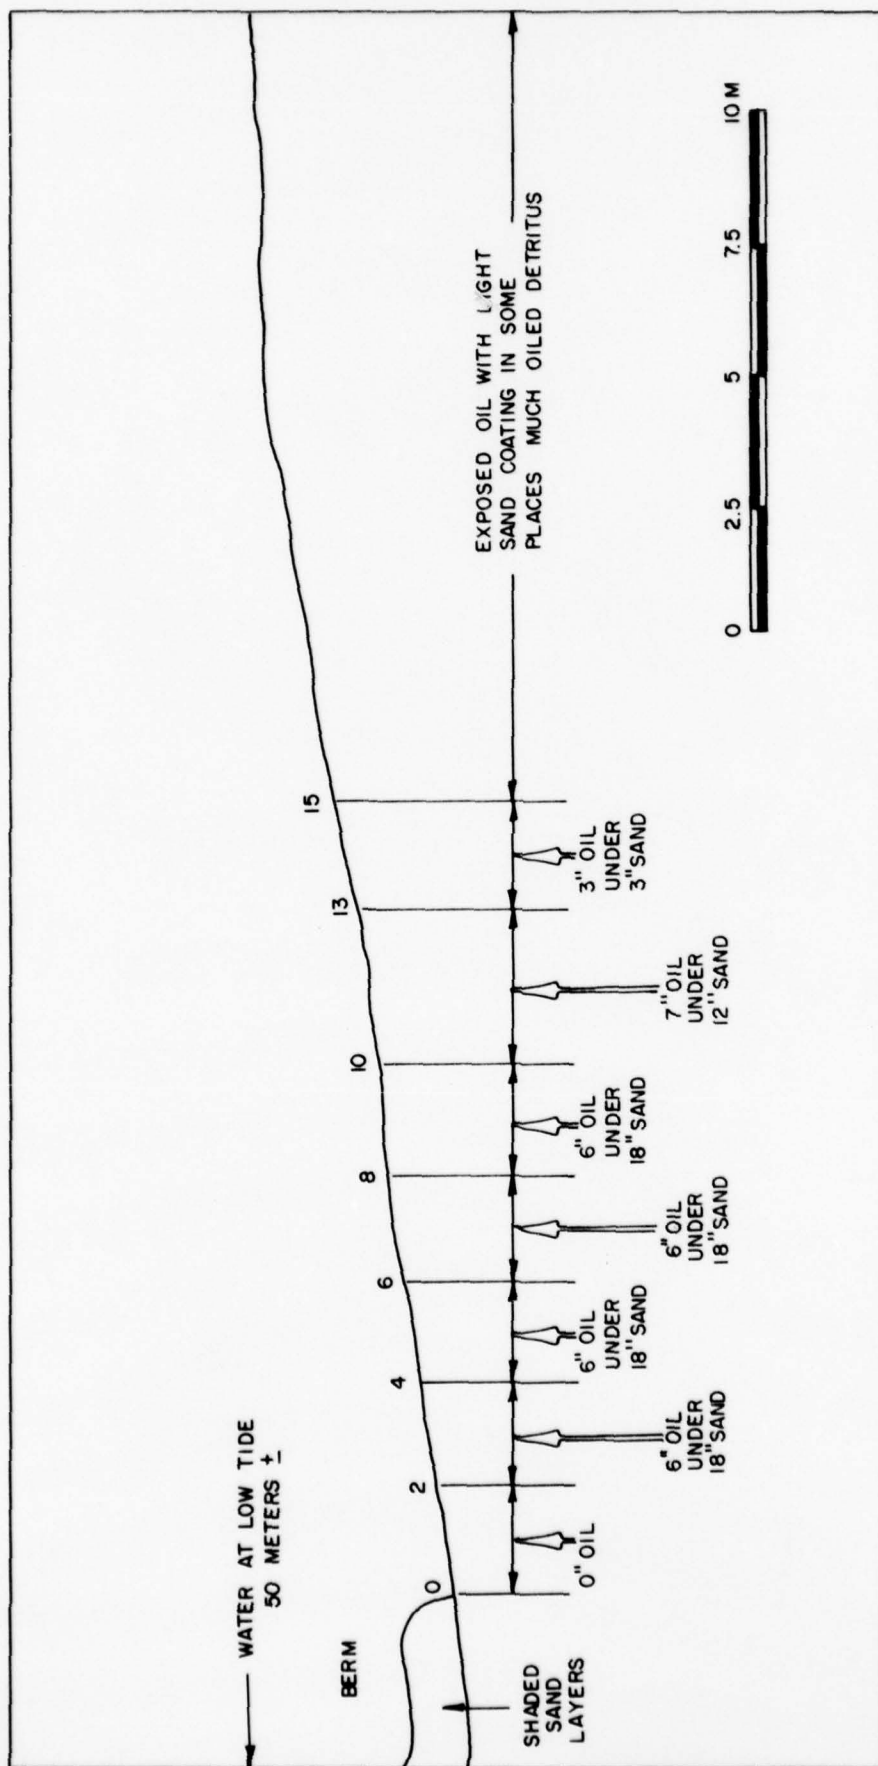
FIGURE 17  
BEACH PROFILE SOUTHEAST ARC AREA BAHIA FELIPE

Figure 17 shows a profile across a typical beach in this area in 1976. At this location oil and mousse was still in evidence over a zone 30 meters (100 ft) wide.

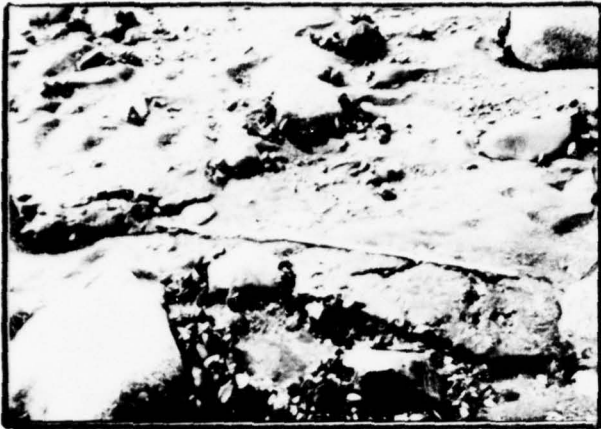
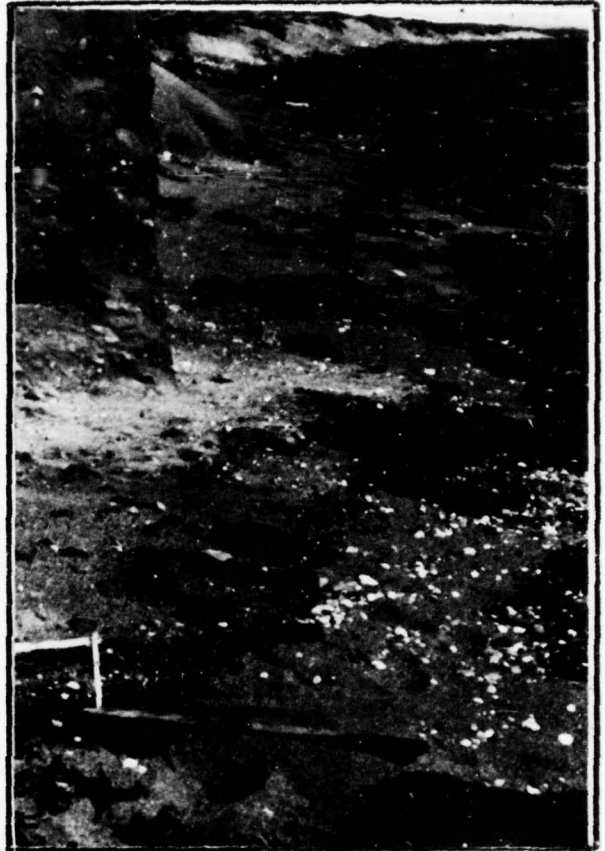
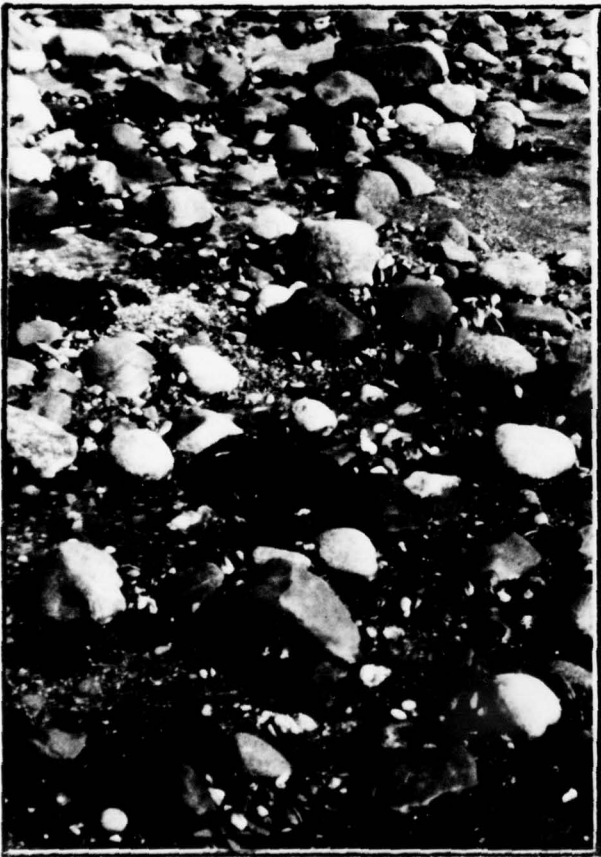
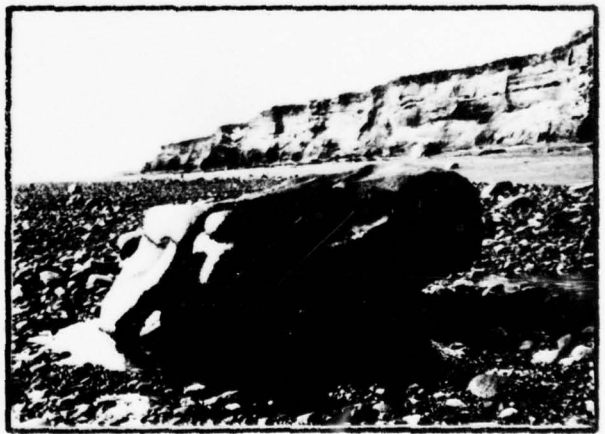
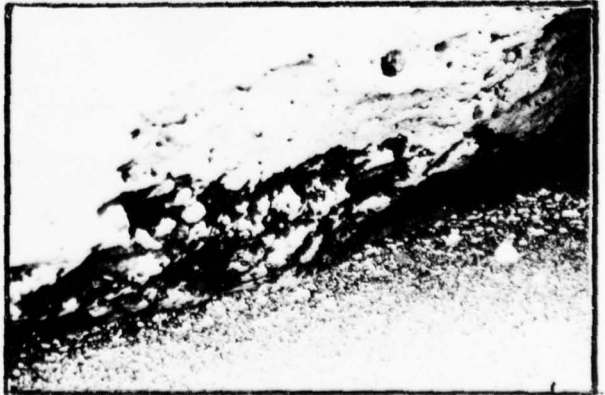
FIGURE 19

There was still evidence in numerous places of a ledge of weathered moussecrete at the top of the beach. This indicates that wave action only occasionally reaches the base of the cliffs. This is further demonstrated in Figure 19 Part F where the oiled top of a small cave is still evident three and a half years after the spill.

Unique in this area are the large number of tar balls and tar slabs found at the base of the beach slope. These are shown in Figure 19 Parts A and B. These may have resulted from the erosion of the oiled zones at the beach top. Since the beach in this area was building at the time the question is raised as to whether there is a large amount of buried oil under the bottom of the beach slope.

From the lighthouse at Punta Baxa to Punta Espora is the exposed south shore of the Narrows. This zone was heavily oiled at the time of the spill but relatively little oil has been observed since. In January 1977 several large rocks such as the one shown in Figure 19 Part C were found to be "painted" with a 1/8 layer of tar. Oil was also found around the edges of the cobbles in the lower intertidal zone.

- A - Tar slabs at bottom of beach face in Punta Baxa area.
- B - Tar balls at bottom of beach face in Punta Baxa area.
- C - Tarred rock face on south shore of First Narrows.
- D - Eroded oil layers at foot of cliffs in Punta Baxa area.
- E - Heavy mussel population on large rock in cobble area near Punta Baxa.
- F - Oil on top of small cave at top of beach near Punta Baxa.

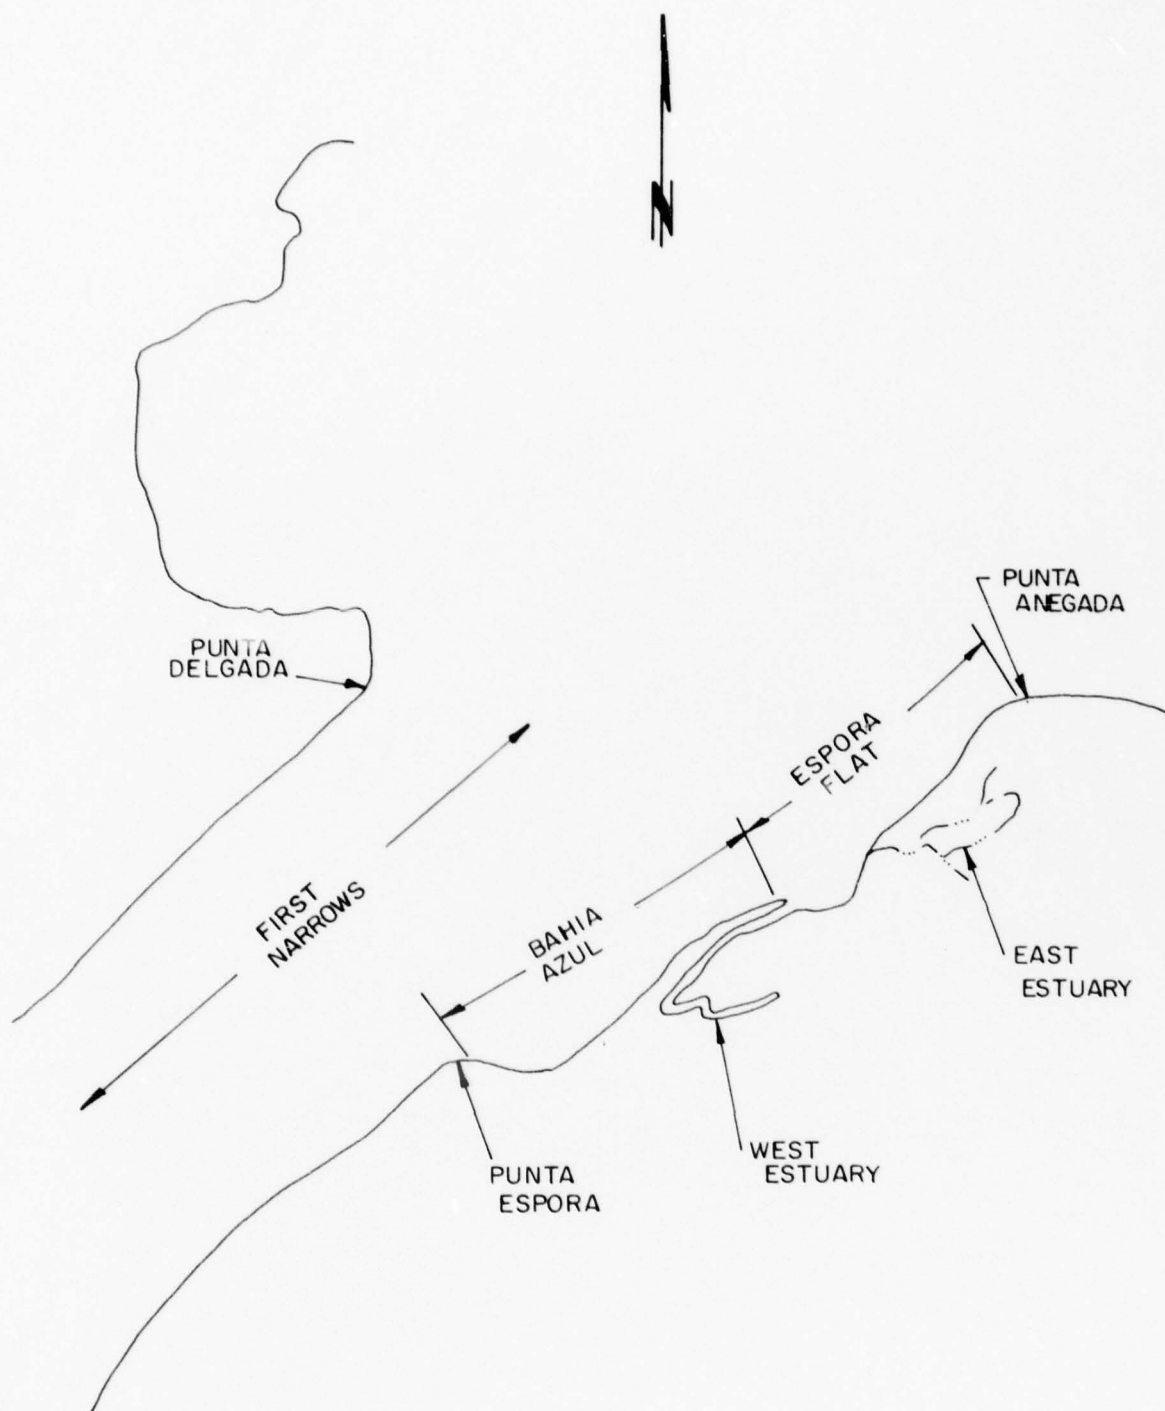
FIGURE 20  
AERIAL VIEW OF SOUTH SHORE OF NARROWS EAST OF PUNTA ESPORA

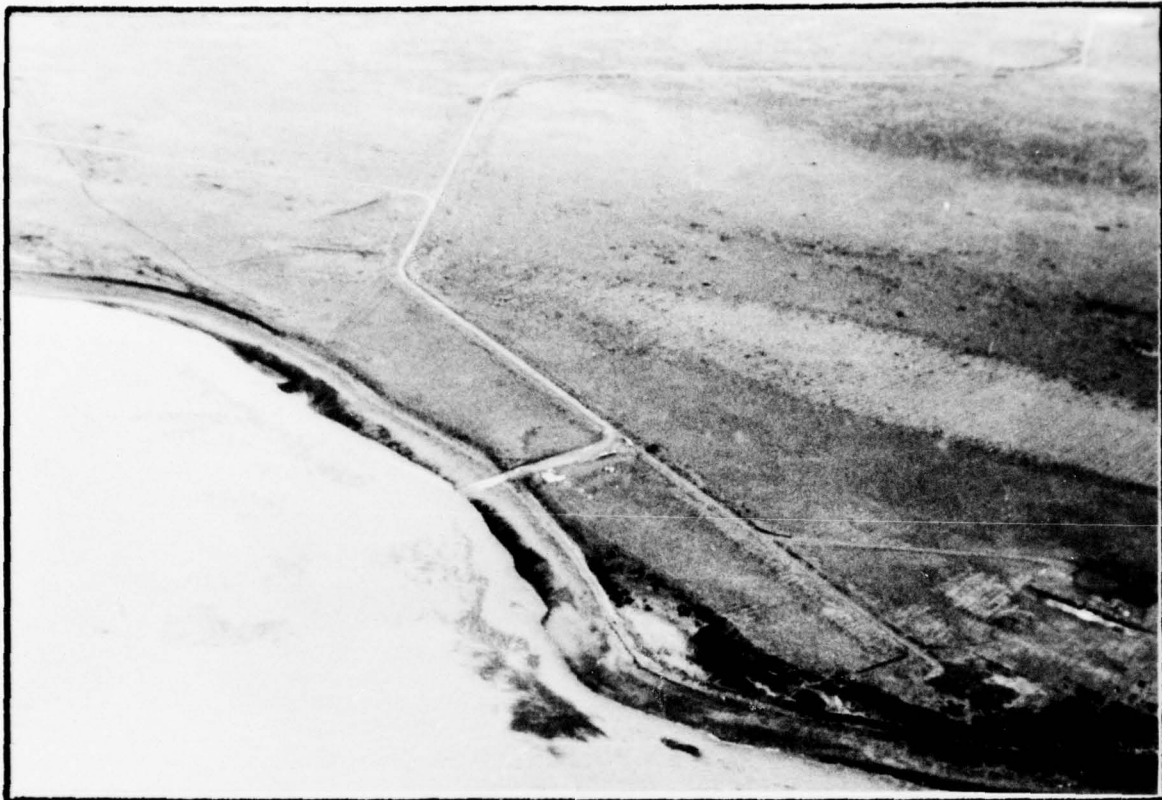
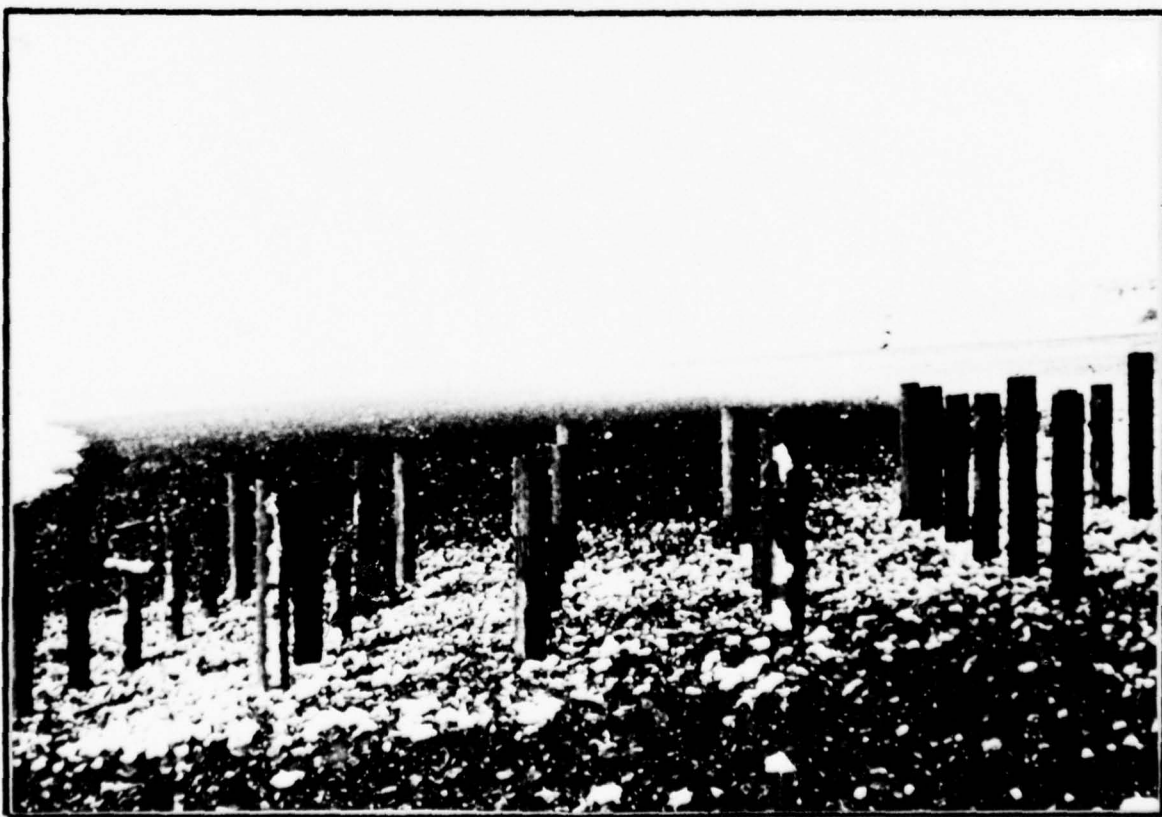
FIGURE 21

The Bahia Azul Beach was not observed at the time of the spill but the construction of the new ferry landing and access road in late 1974 made observation possible in January of 1975. Figure 21 Part B shows the Azul Beach at the new ferry landing. The clean undersides of rocks disturbed by the construction contrasted drastically with the oiled beach face in the foreground and background.

- A - View of Bahia Azul Beach showing new road and ferry loading. Punta Espora is in the lower lefthand corner.
- B - View of oiled beach face on Bahia Azul. New construction has turned over rocks in piling area in contrast to oiled rocks in foreground and background.

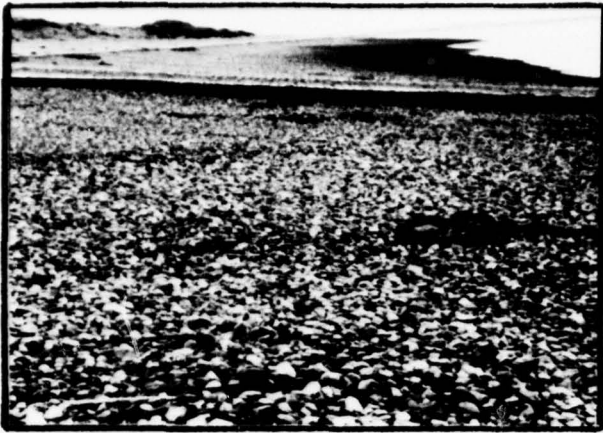
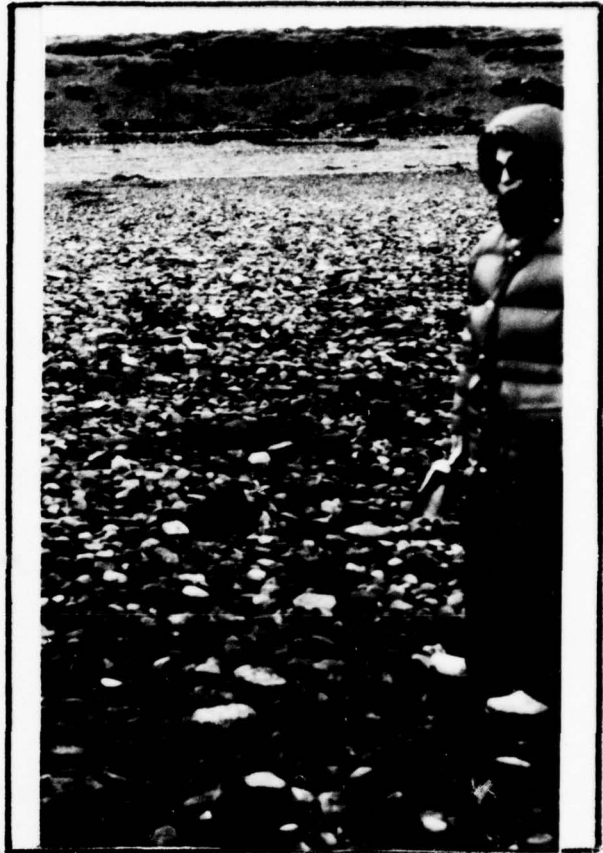
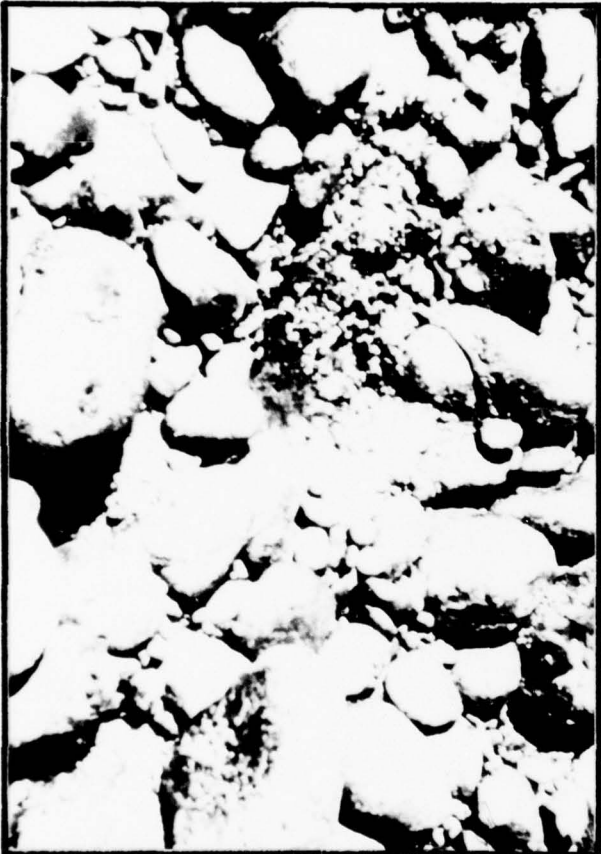
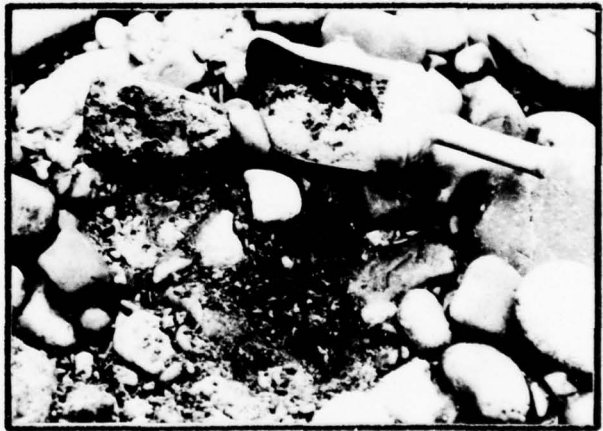
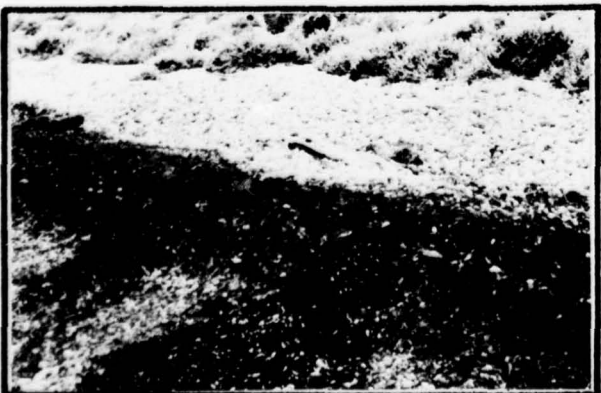
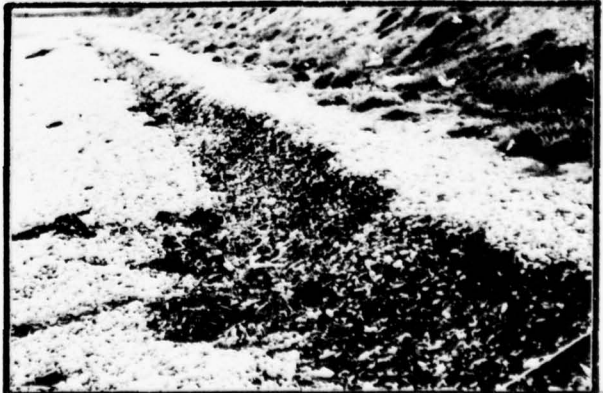
FIGURE 22

The entire beach zone in this area is heavily oiled. Figure 22 Parts A through F shows views of this beach in 1975 and 1978. Figure 23 shows a beach profile made in 1975. Almost an identical profile was observed in 1978 except for the relative absence of oil in the sandy zone between the oiled layer at the top (Figure 22 Parts C and F) and the paved cobble area shown in Figure 22 Parts A, B, D and E.

- A - Paved beach to south of New Ferry landing on Bahia Azul.
- B - Closeup of oiled pavement on Bahia Azul Beach.
- C - Oiled shell and flat stone beach top deposit in January 1975.
- D - Series of sampling pits perpendicular to the beach on Bahia Azul shore.
- E - Closeup of oiled pavement.
- F - Oiled shell and flat stone beach top deposit in January of 1978.
